Monitoring Data RecordProject Title: R-2210A Site 1 (Waynesville Site 1) COE Action ID: 200130653Stream Name: Raccoon Creek DWQ Number: 010409City, County and other Location Information: Sta. 30 on Bus. 23 S in Waynesville, Haywood Co.Date Construction Completed: July 2003 (lower portion), 2005 (upper portion)

Monitoring Year: (5) of 5

Year 5 Winter – March 2009

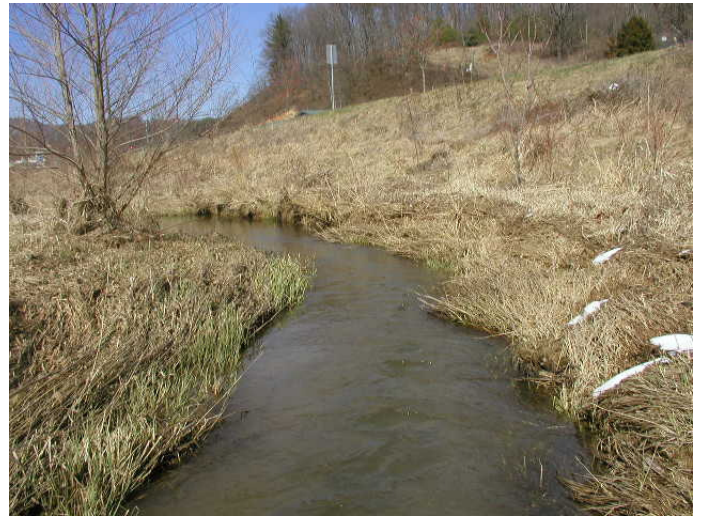
Photo 2 (Downstream)

3/4/09	Sta. 30+20 Photo 2 Downstream	Sta. 30+60 Photo 4 Downstream	Sta. 31+10 Photo 5 Upstream	Station Number	Station Number
Structure Type					
Is water piping through or around structure?					
Head cut or down cut present?					
Bank or scour erosion present?	Bank scouring on right bank	Bank scouring on left bank.	Bank scouring behind rootwad on right bank		
Other problems noted?

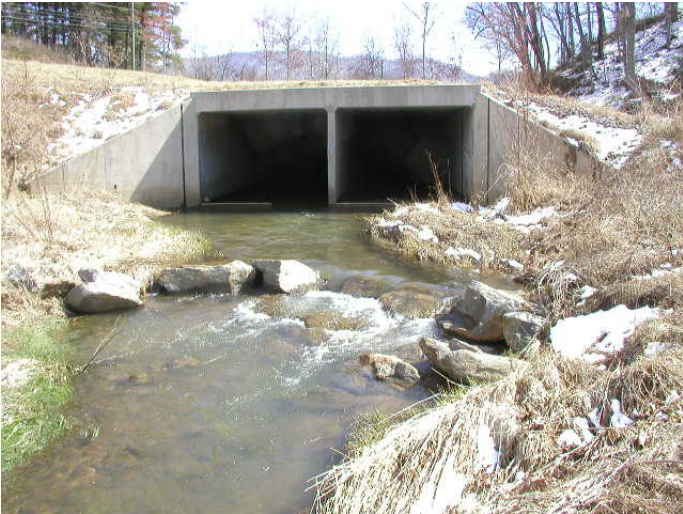
Additional photo of crossvane at outlet of double barrel box culvert
